Investigation report for torque spike at Cell #1 in GM NVH Milford BLD#94

Feb 16<sup>th</sup> 2004

MEIDENSHA Dynamometer Div.

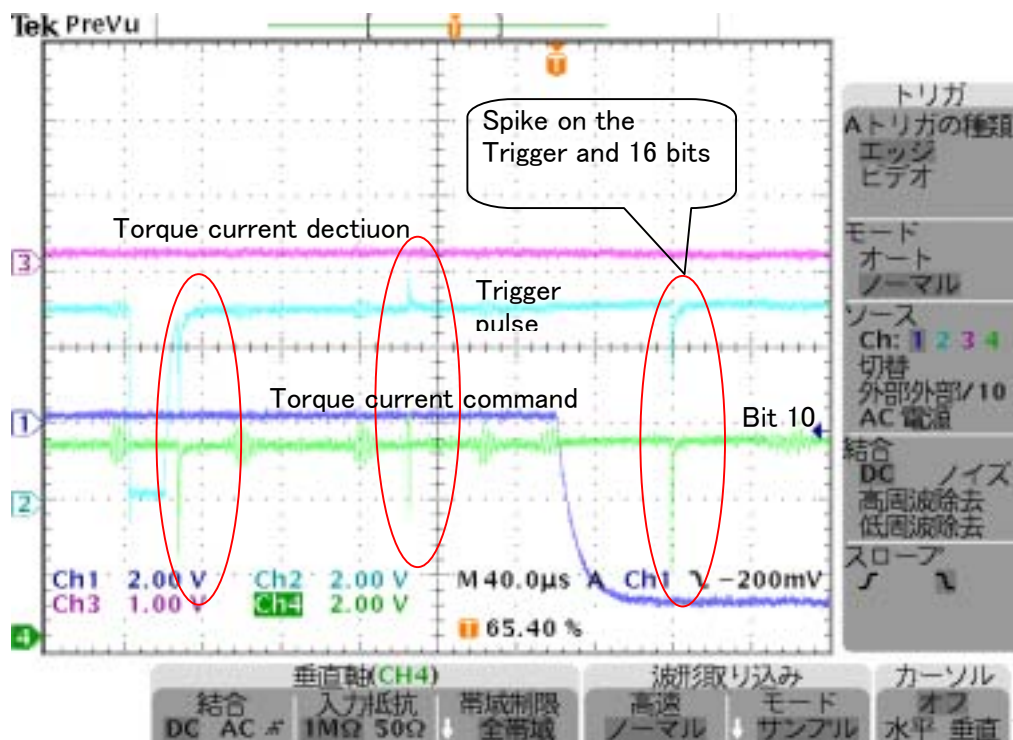
Picture 1

Spike Noise, on the torque current command signals of 16 bits and trigger for command reading, was coming through MTS controller and was cause of spike torque.

We checked trigger signal and certain bit signals at parallel connector in MEIDEN parallel - serial interface unit. Then it appeared spike noise simultaneously on all 16 bits and trigger signal.

As showing picture 1, deep spike noise on the trigger and all bits allowed to create unexpected current command so that MEIDEN box grabbed bit status when the trigger was low level to high level.

For the torque current command, noise did not interfere frequently so that it was narrow width, random frequency and amplitude.

To eliminate noise, we put capacitors (0.01micro F) on 16 bits in MEIDEN Box.

MEIDEN asked GM to change trigger timer from 10micro sec to 50 micro sec so that time constant of bit signal from L to H became longer.

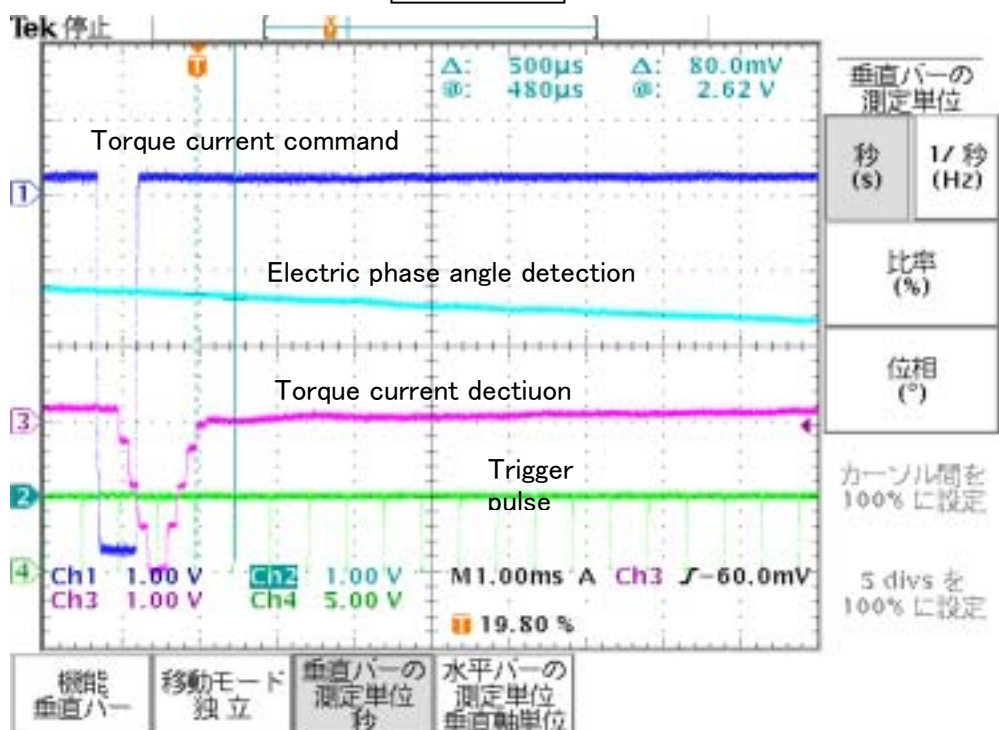
Picture 2

We considered the recorder data that was taken by Sasaki on December and it shown that torque current command had spike and torque current detection was followed it.

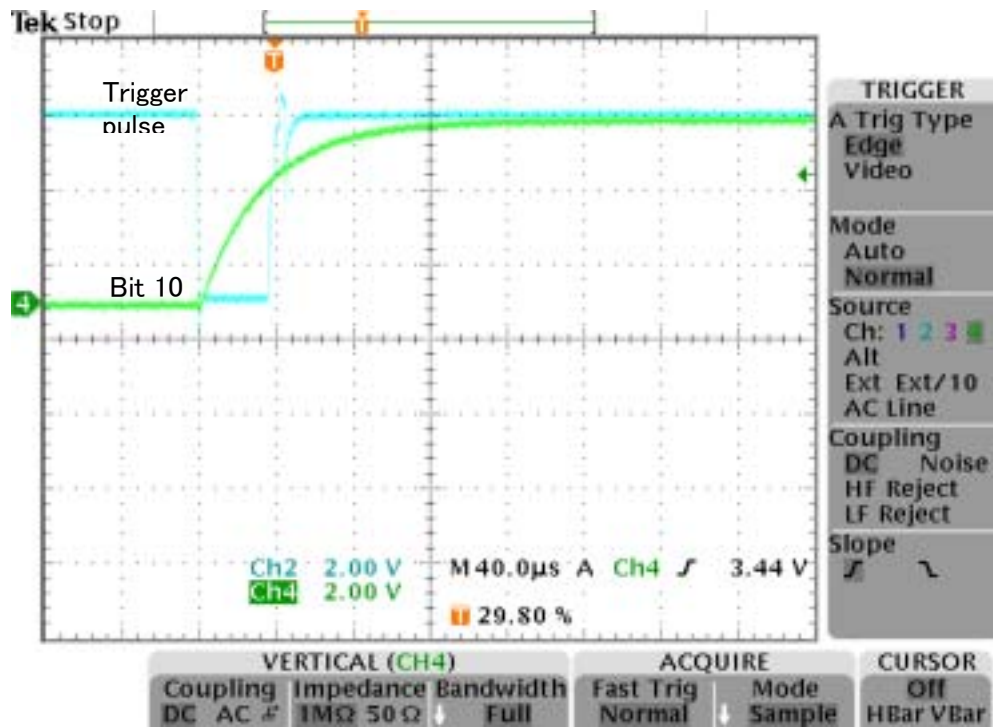
Picture 3

After putting on capacitors, we confirmed signal status that noise was eliminated to all 16 bits for both Cell#1 and #3.
