## THE HEINKEL HE 111 IN SPAIN

## Heinkel He 111 losses in chronological order - 49 in total

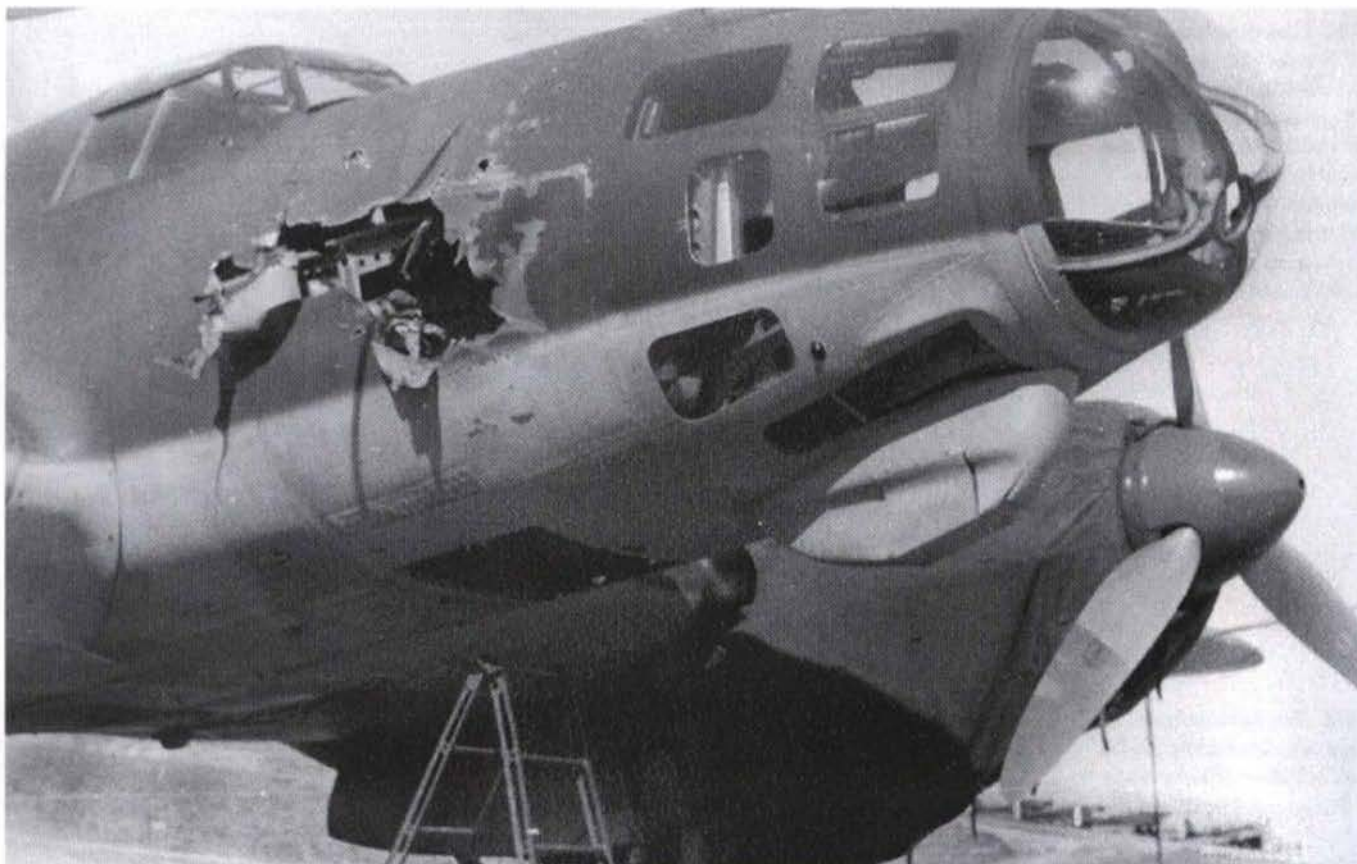
277 Above left: This close up of the nose of an unidentified Heinkel He 111E gives graphic evidence of the impact of a flak shell which has obviously penetrated the bomb-aimers compartment before exploding outwards through the starboard side. Apart from the immediate damage the aircraft appears to be in mint condition. Note that the nose machine gun has been removed from its socket in the

rotating Ikaria mounting. Underneath the nose the fairing over the external bombsight is clearly visible. As the spinners appear to be red, this may be a machine of 2.K/88. Three Junkers Ju 87Bs can just be made out in the far distance, so the picture probably dates from late 1938-early 1939 and the location is most likely Sanjurjo

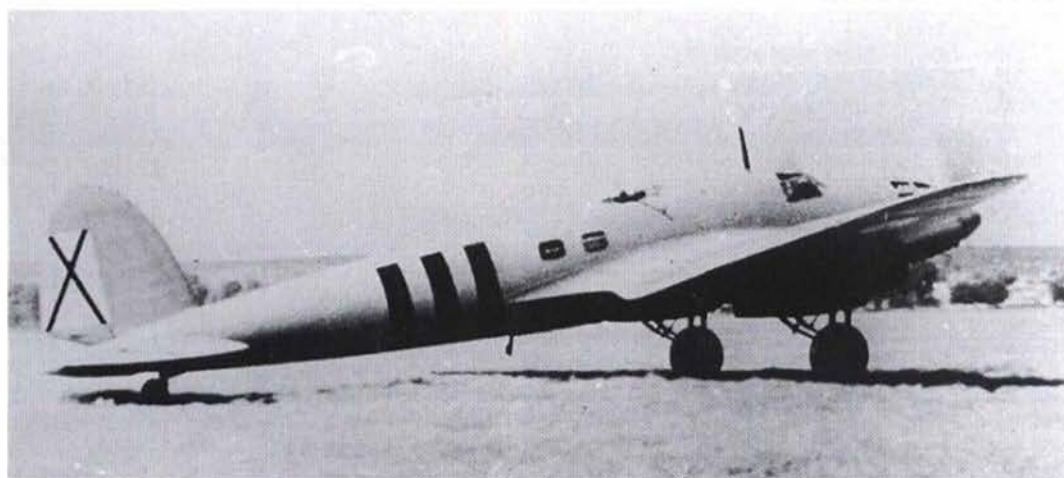
278: In order to be able to stop at the Balearic islands bases, the first Heinkel He 111Bs received this very conspicuous fuselage marking, which corresponded to that of the Nationalist air units based in Mallorca.
